CERTIFICATE OF APPROPRIATENESS

Property: 1505 South Blvd, Lot 5, Tract 6A Broadacres Subdivision. The property includes a historic 6,700 square foot, two-story brick single-family house with a detached garage situated on a 79,870 square foot interior lot.

Proposal: Alteration - Remove all wood 1-over-1 and casement windows and non-original wood doors on the residence and replace with 1-over-1 and casement wood windows and doors with 5/8" insulated glazing.

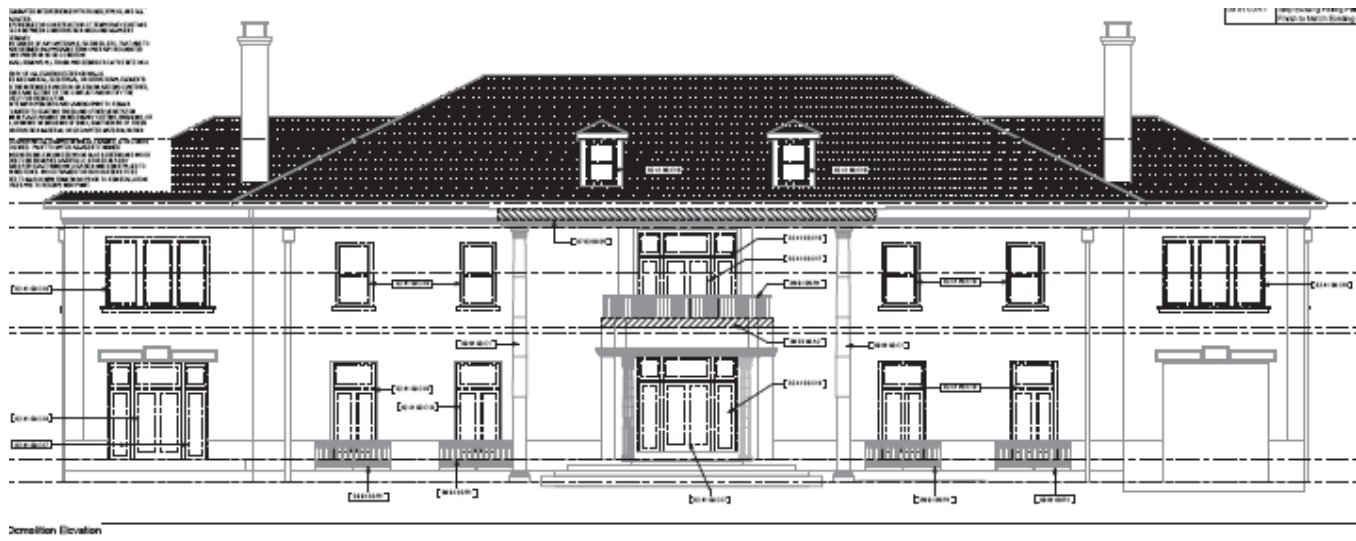
NORTH ELEVATION – FRONT FACING SOUTH BOULEVARD

Front Elevation: On the first floor ten windows, six transom windows and one set of doors will be replaced. On the second floor eleven windows, one transom and one set of doors will be replaced. On the third floor two windows will be replaced.
(North)

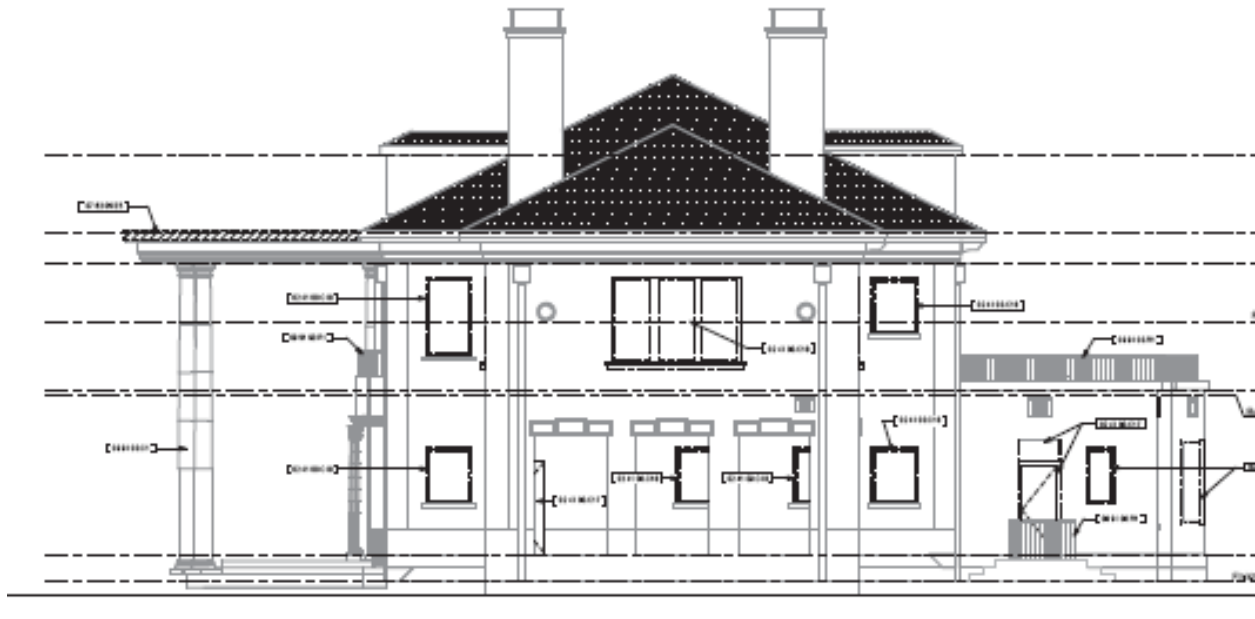
WEST SIDE ELEVATION

Side Elevation: On the first floor four windows and one door will be replaced and on the second floor four windows will be replaced.
(West)

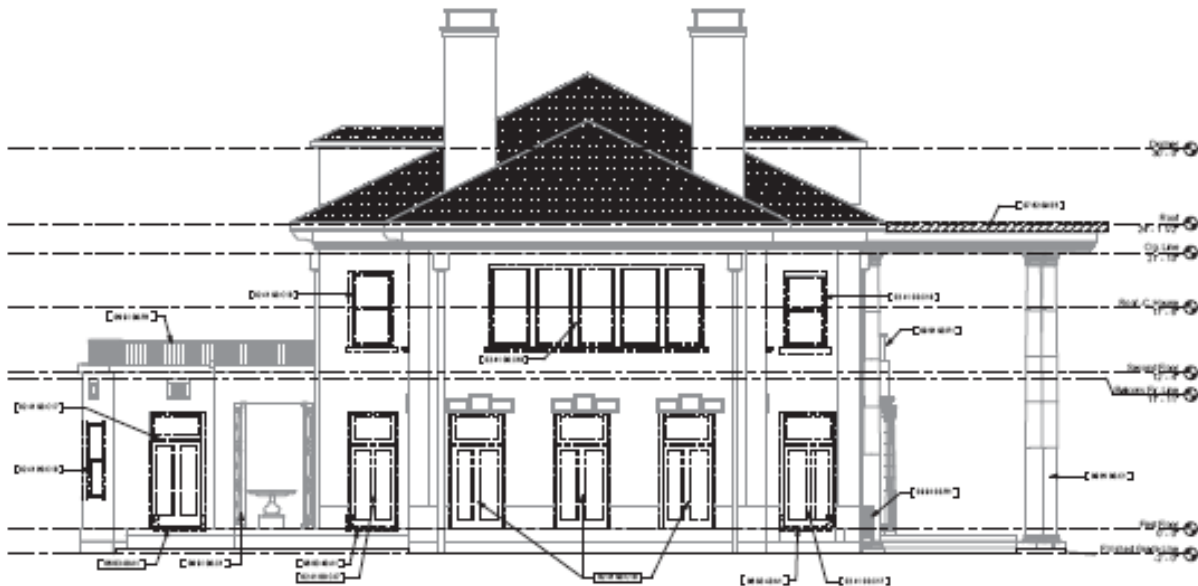
EAST SIDE ELEVATION

Side Elevation: On the first floor four windows and transoms will be replaced. On the second floor six windows will be replaced.
(East)

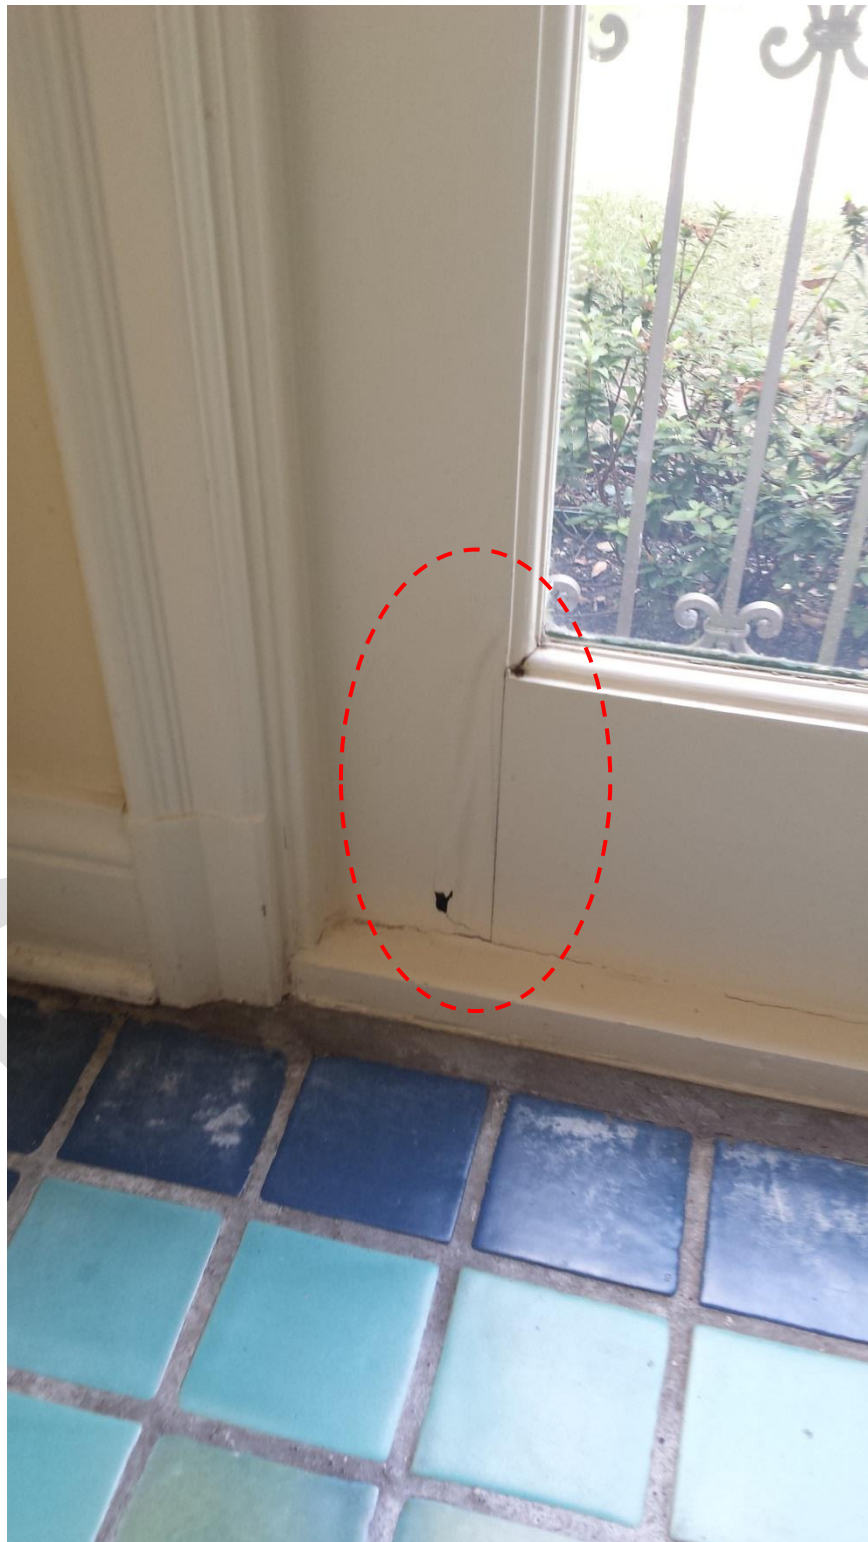
WINDOW DAMAGE

<i>The original wood windows are distinguishing features of the property and should be retained. Staff confirmed that some windows had minor moisture damage, but were not damaged beyond repair.</i> |

Recommendation: Partial Approval: Approval to replace both first and second floor doors and denial to replace the original 1-over-1 and casement windows.
